<p>Project Name</p> <p>Project Date</p> <p>End Client</p> <p>Suffcon's Client</p> <p>Total Project Value</p> <p>Suffcon's Project Value</p>	<p>MARANOA REGIONAL COUNCIL Sewer Rectification Program</p> <p>Jan 2019</p> <p>Maranoa Regional Council</p> <p>Maranoa Regional Council</p> <p>\$3,00,000.00</p> <p>\$500,000.00</p>
<p>Project Scope</p>	<p>The works formed part of the MRC Sewer Relining Project, funded by Local, State and Federal government agencies. Suffcon effected repairs to defective MRC Sewer Mains and Manhole Assets in preparation for a Sewer Relining Contactor.</p>
<p>Suffcon Scope</p>	<p>Working with Live Sewer infrastructure whilst maintaining all live commercial and house connections. Property Owner Consent process. Removal and reinstatement to pre-works condition of structures, slabs, fences, landscaping, driveways, carparks, various pavement surfaces, footpaths and roads. 82 repairs have been completed with more to come in the next round of funding. Construction of new manholes and connections. Relaying of two Manhole to Manhole Sewer Mains, including upsizing pipework and associated property connections remaining live. Large bore sewer pumps were utilised to pump a

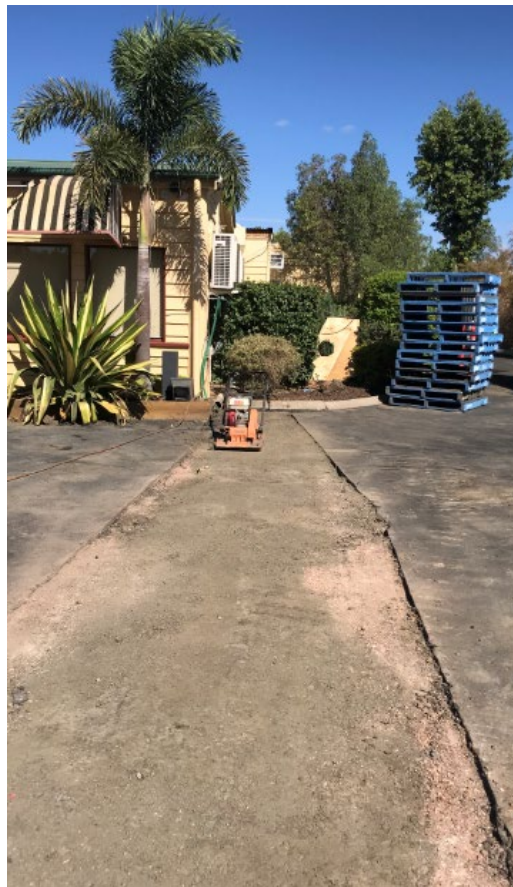
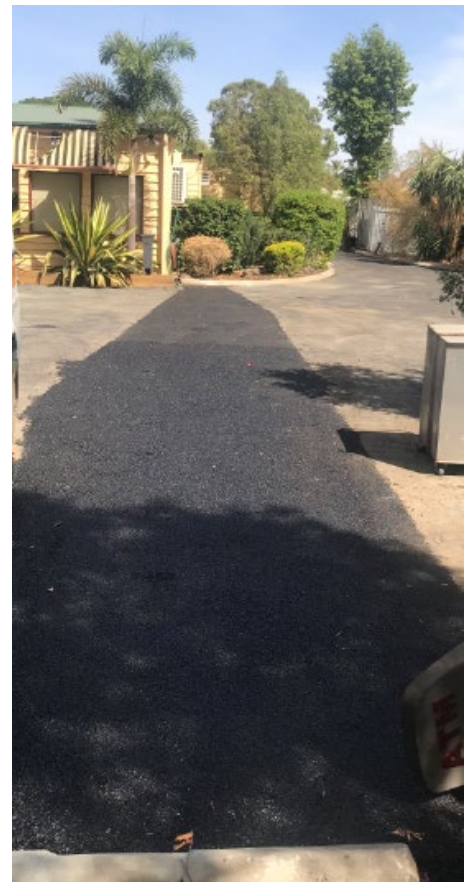
PAVEMENT REINSTATEMENT

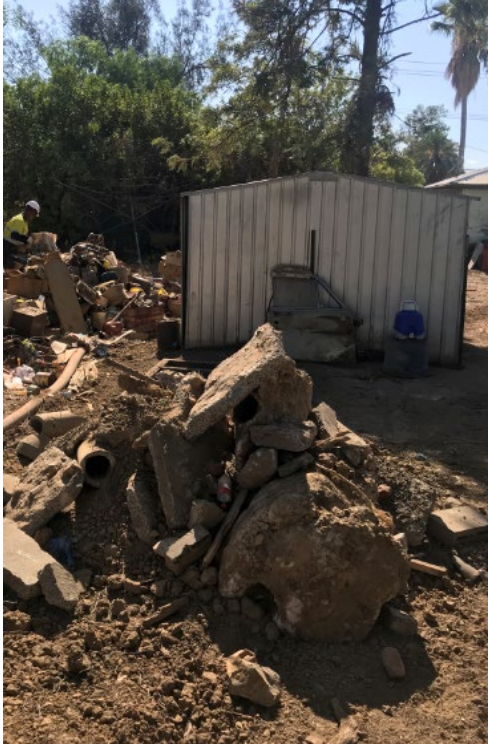
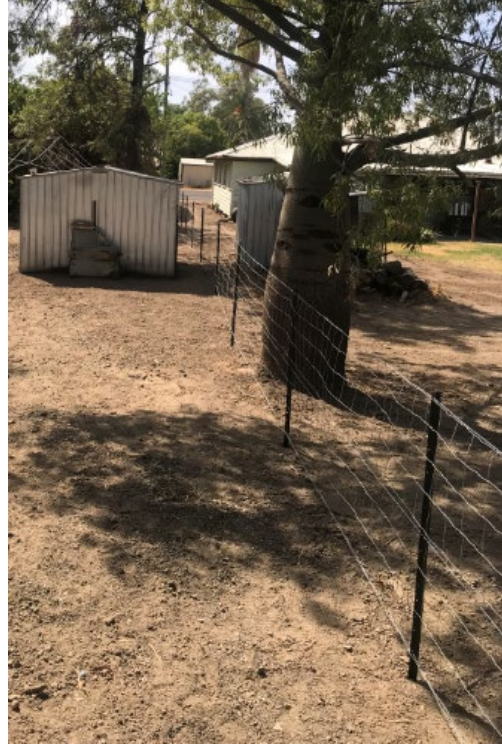
BEFORE AND AFTER

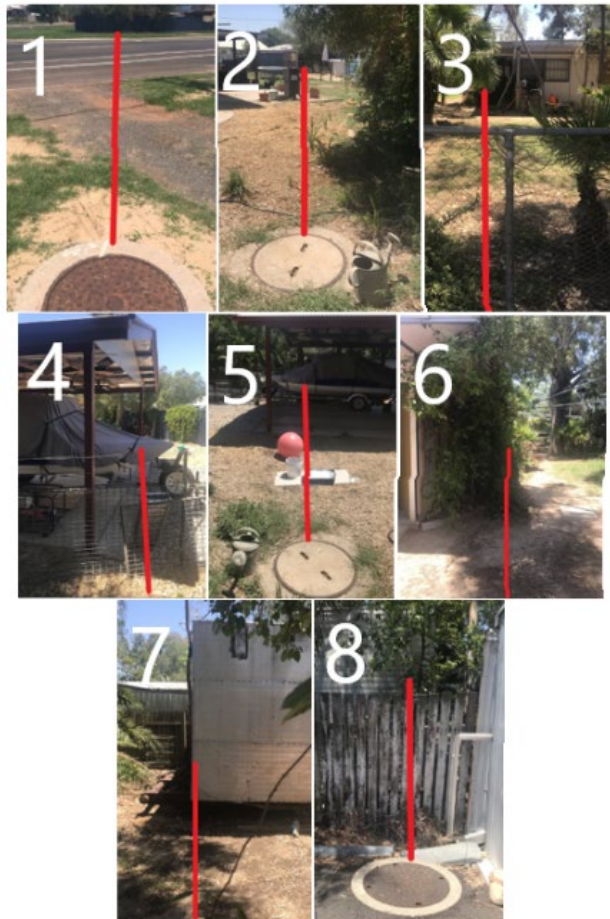
TYPICAL PREWORKS SCOPE
